**STATE OF HAWAII
DEPARTMENT OF LAND AND NATURAL RESOURCES
OFFICE OF CONSERVATION AND COASTAL LANDS
Honolulu, Hawaii**

July 28, 2006

REGARDING: Conservation District Enforcement File No. OA-06-32
Regarding Alleged Unauthorized Construction of Rock
Walls Within the Conservation District

LOCATION: Submerged Land
makai of 91-702 Oneula St
Oneula Beach, Ewa, Island of Oahu

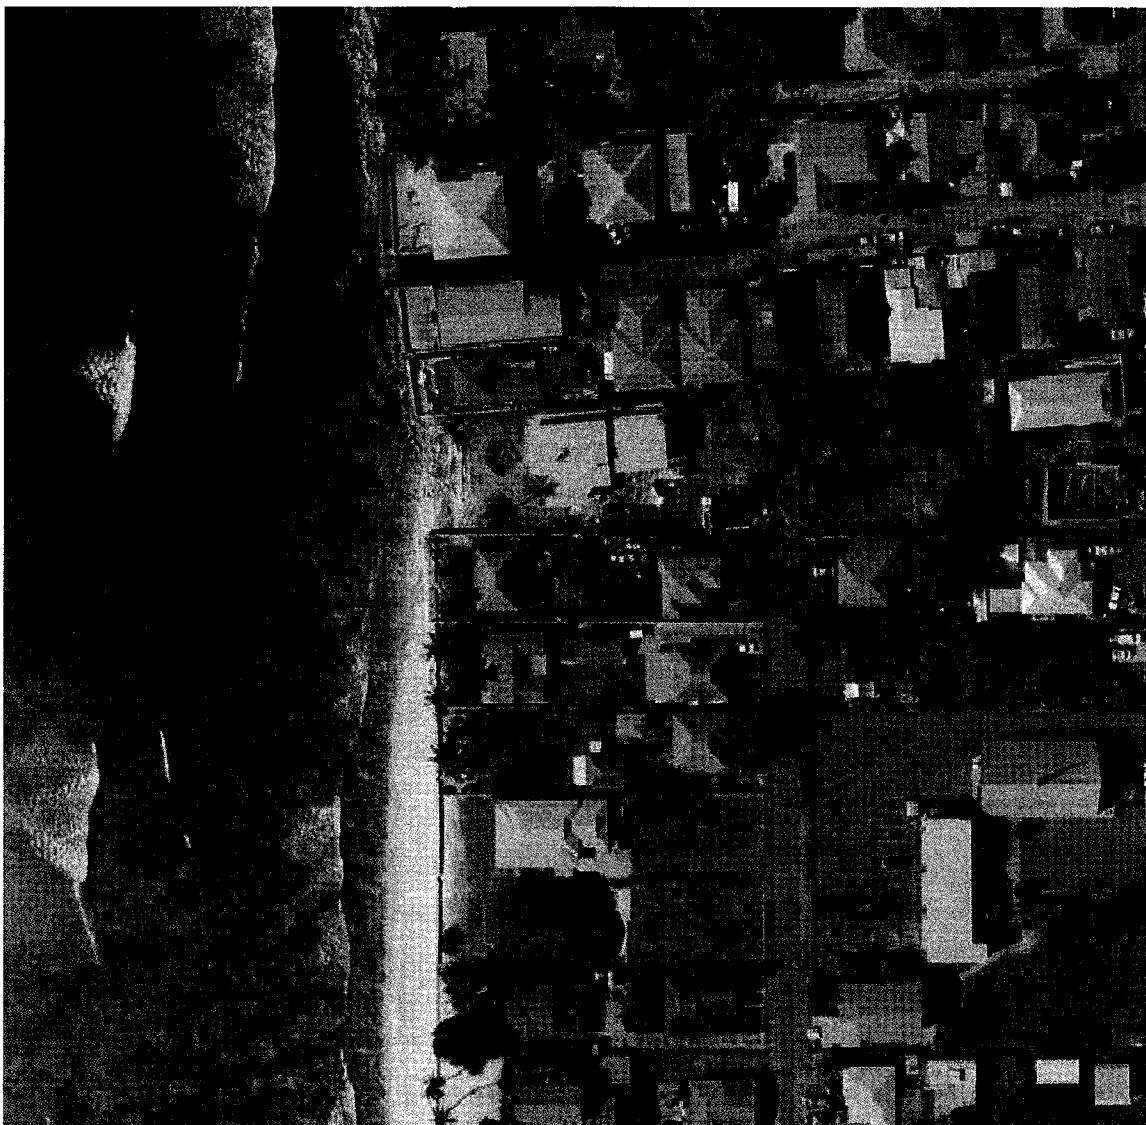
Hi resolution Aerial photographs were acquired for Oahu shoreline on Dec 16, 2005 and Dec 30, 2005. Images were collected on 9 by 9 inch color film at scale 1:9000.

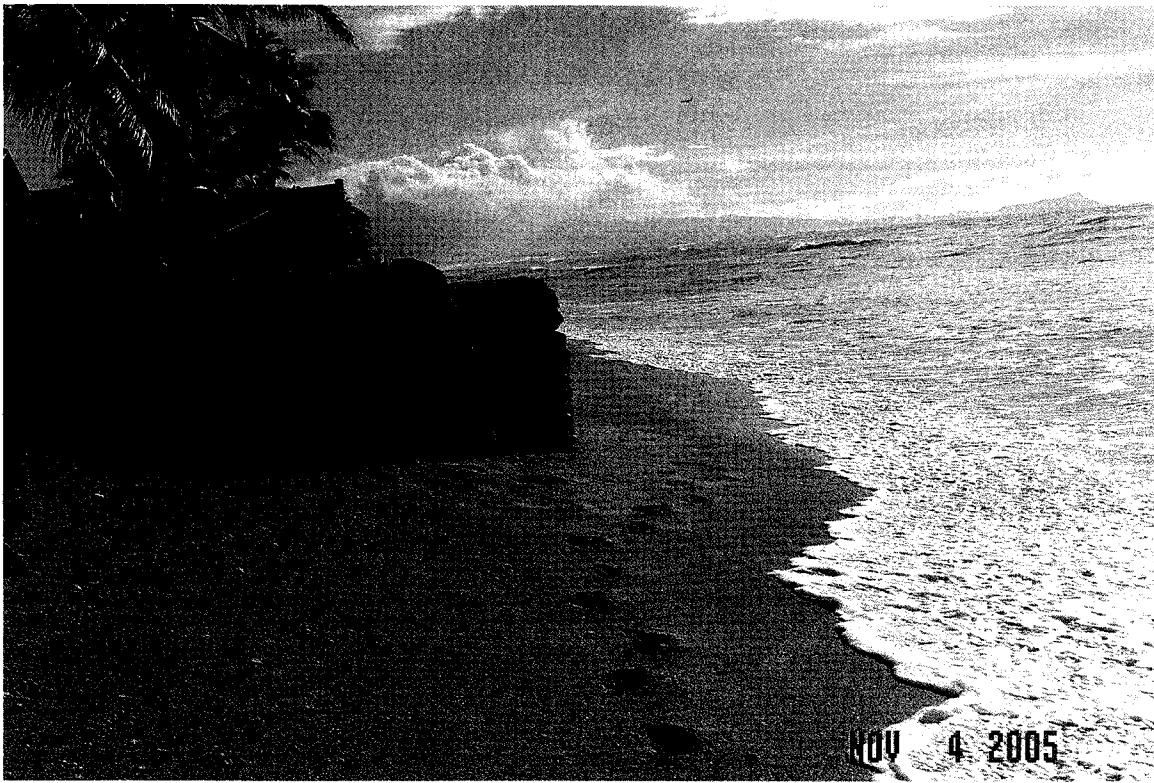
Photo 8-Subject wall is the wall furthest mauka of the shore.

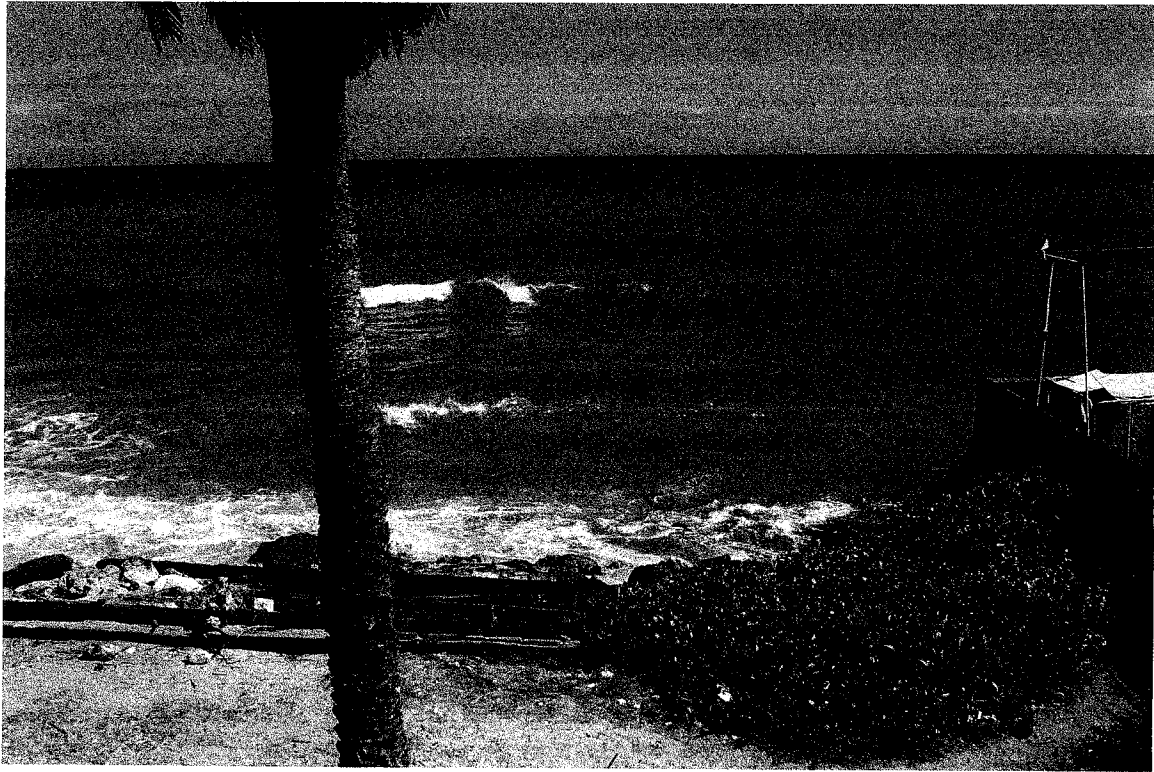
Gate tot eh Wainae side (left) enters our lot on path seen before vegetation line. This gate was used to pass between lots and also as an area for the sale of sodas to those fishing in our lot. Gate had sign with prices of sodas posted on it.

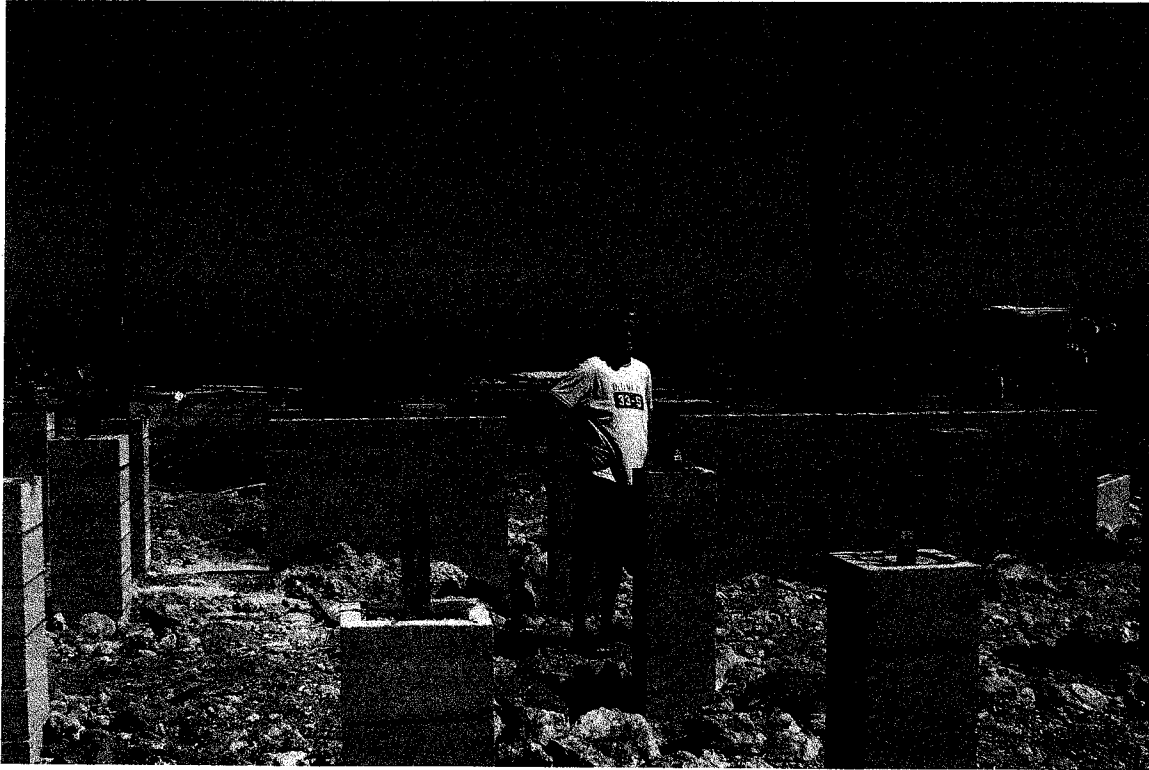
Gate at arrow.

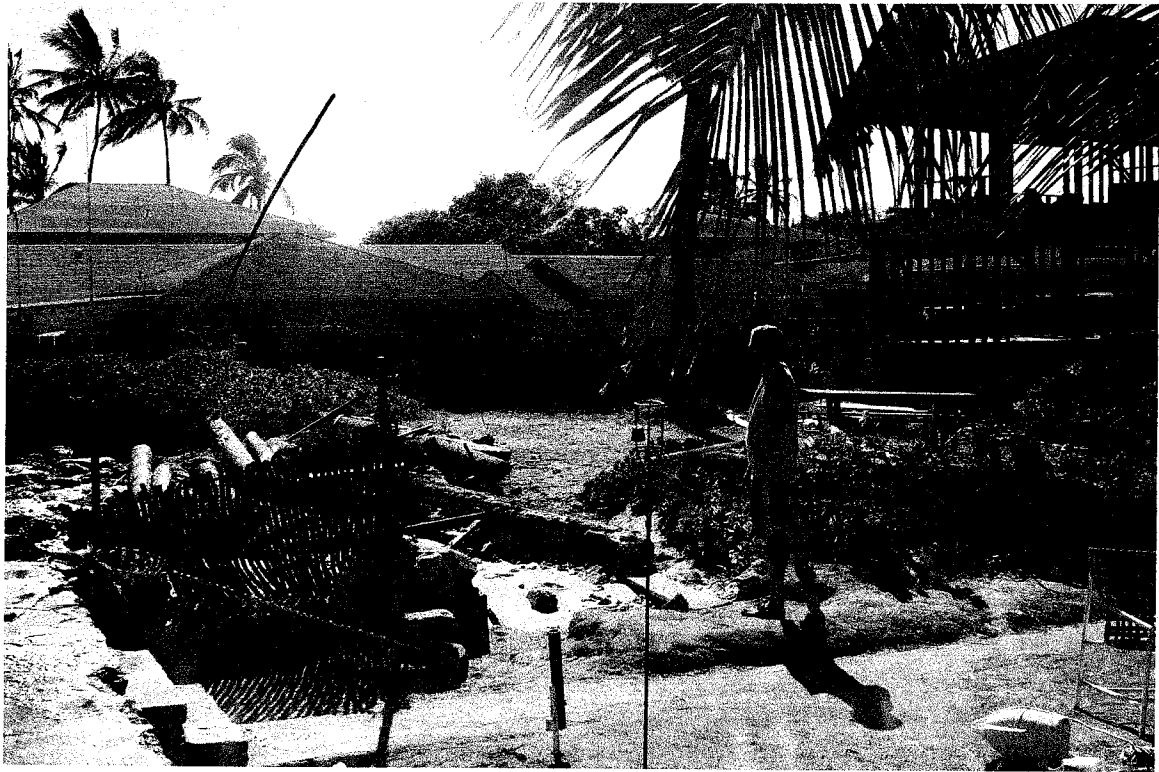
Proximity of new house and vegetation line...gate seen at arrow (Wainae side).
